**GSA RECLAMATION YARD, SWMU NO. 010  
SOUTHWEST HOT SPOT INTERIM MEASURE  
PERFORMANCE MONITORING REPORT  
KENNEDY SPACE CENTER, FLORIDA**

**National Aeronautics and Space Administration  
Kennedy Space Center, Florida**

**December 2015  
Revision 0**

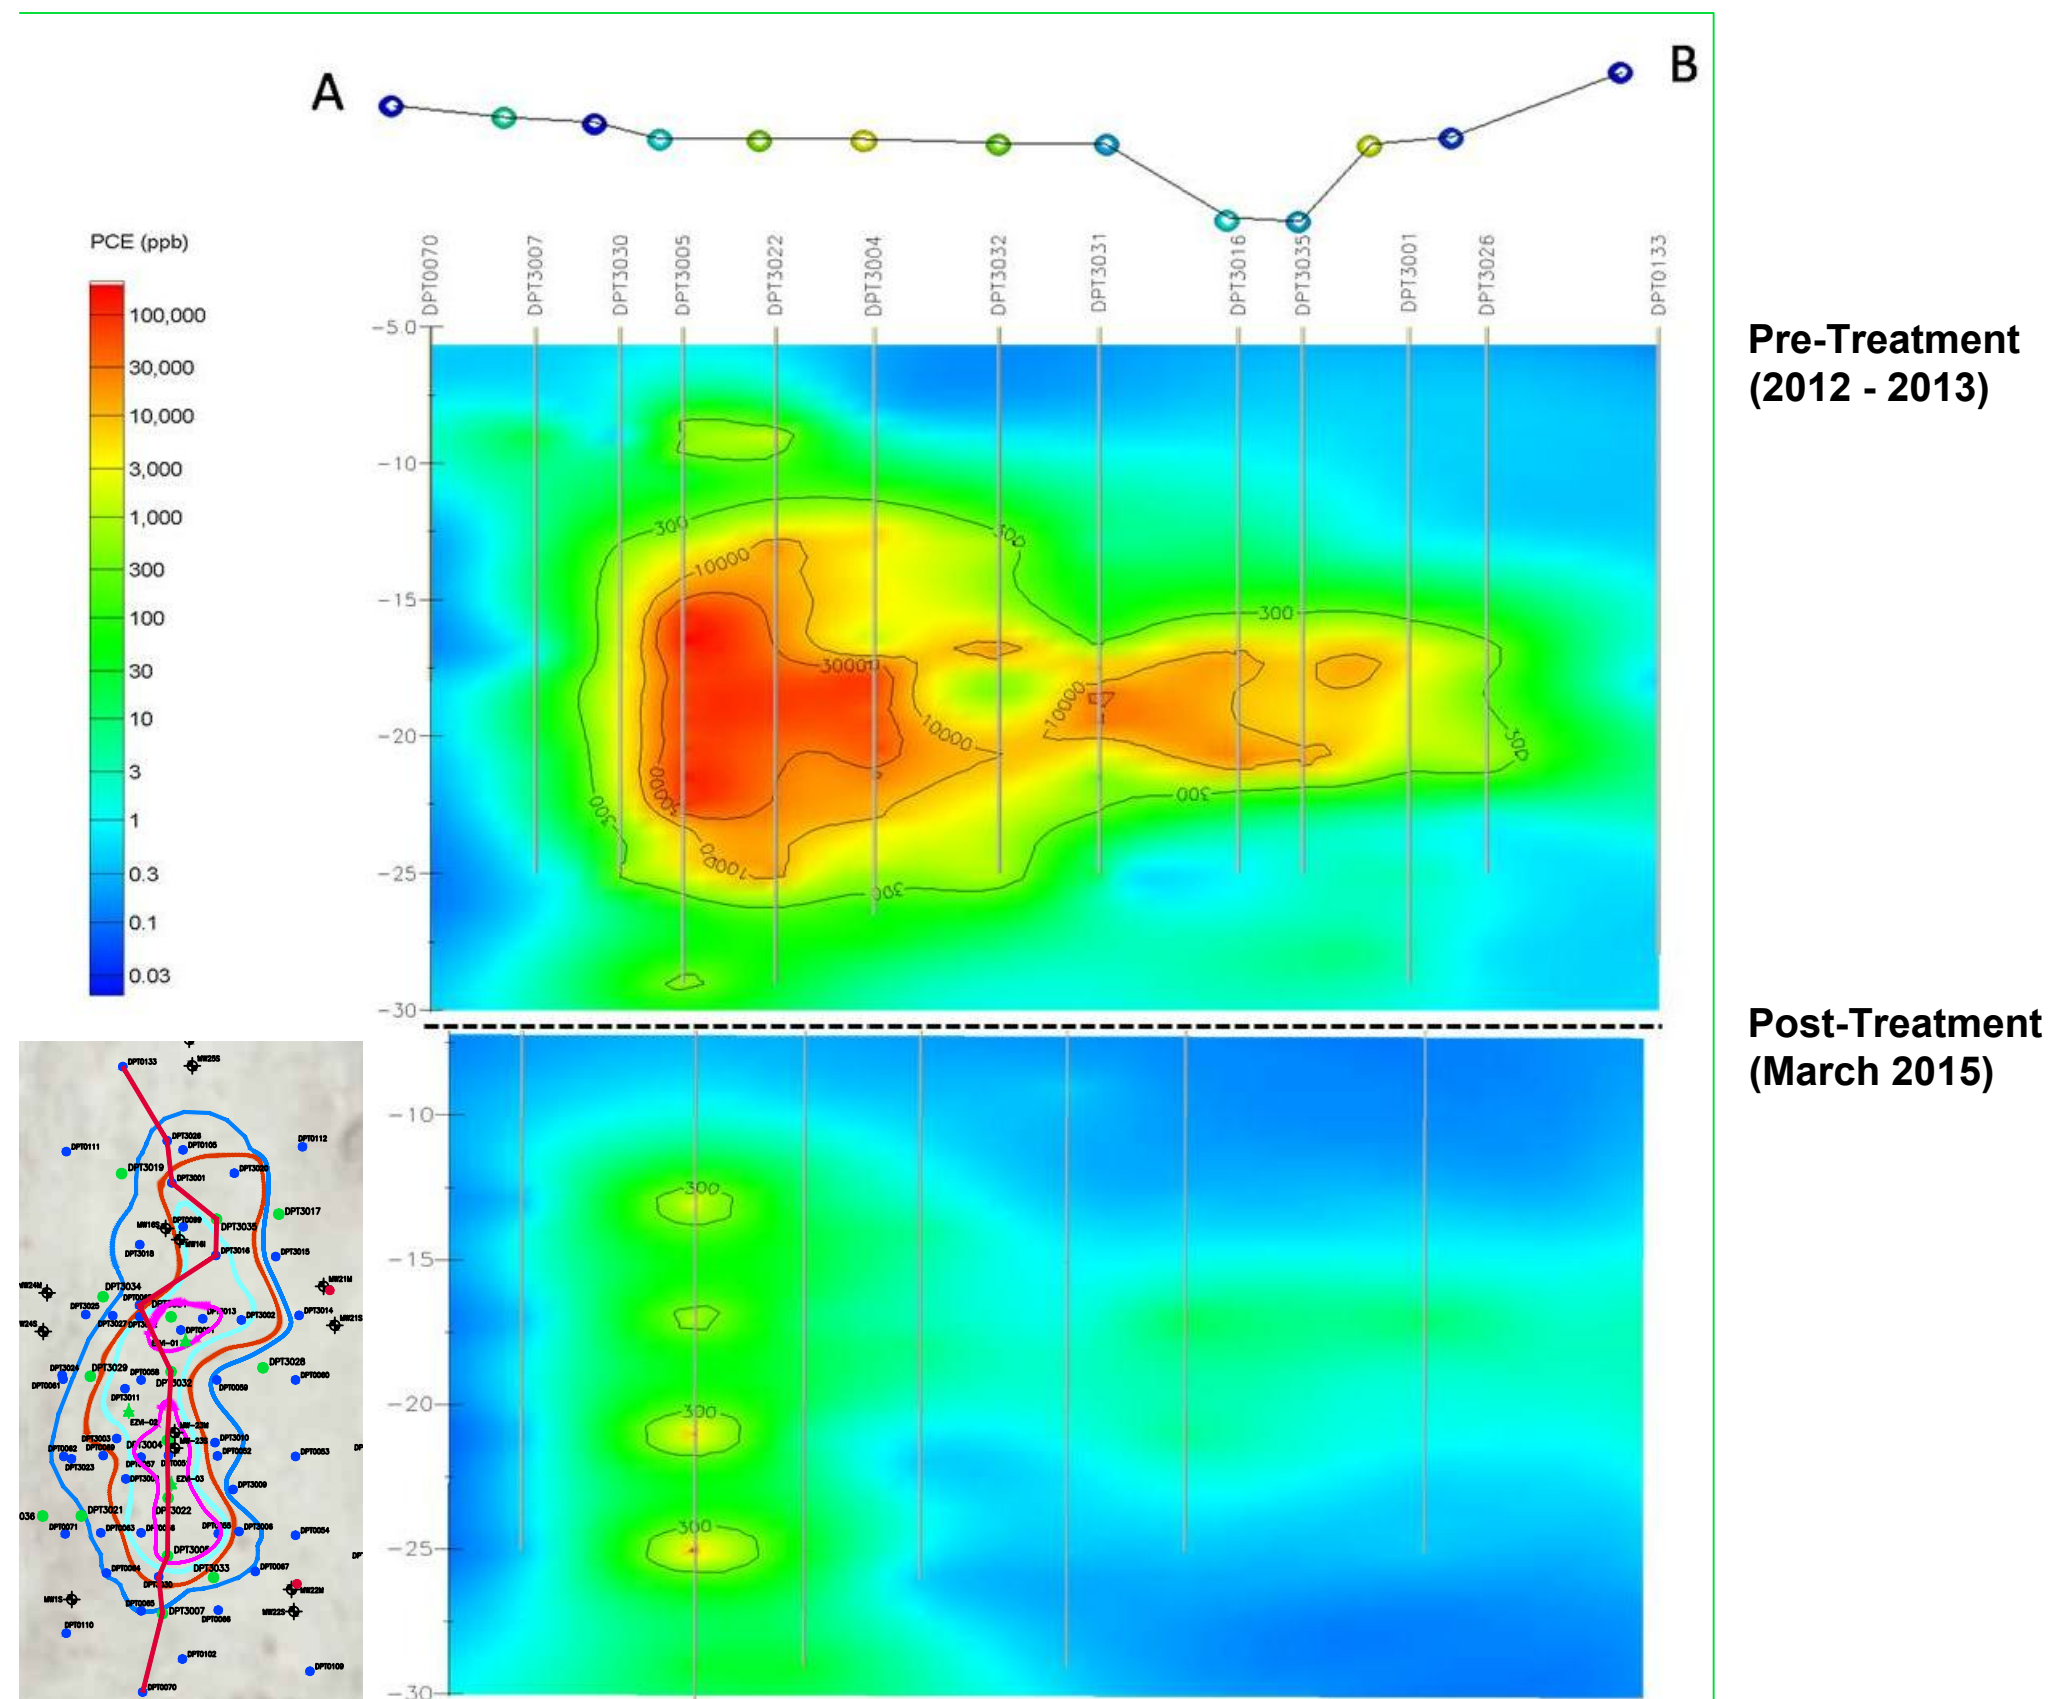
Figure 5-2b

**PCE Cross Section with 300, 10,000, 30,000 ppb Isopleths (PM Data Only for Post-Treatment)**

GSA Reclamation Yard  
Southwest Hot Spot Interim Measure  
Pre- and Post-Treatment PCE Cross-Section Using EVS

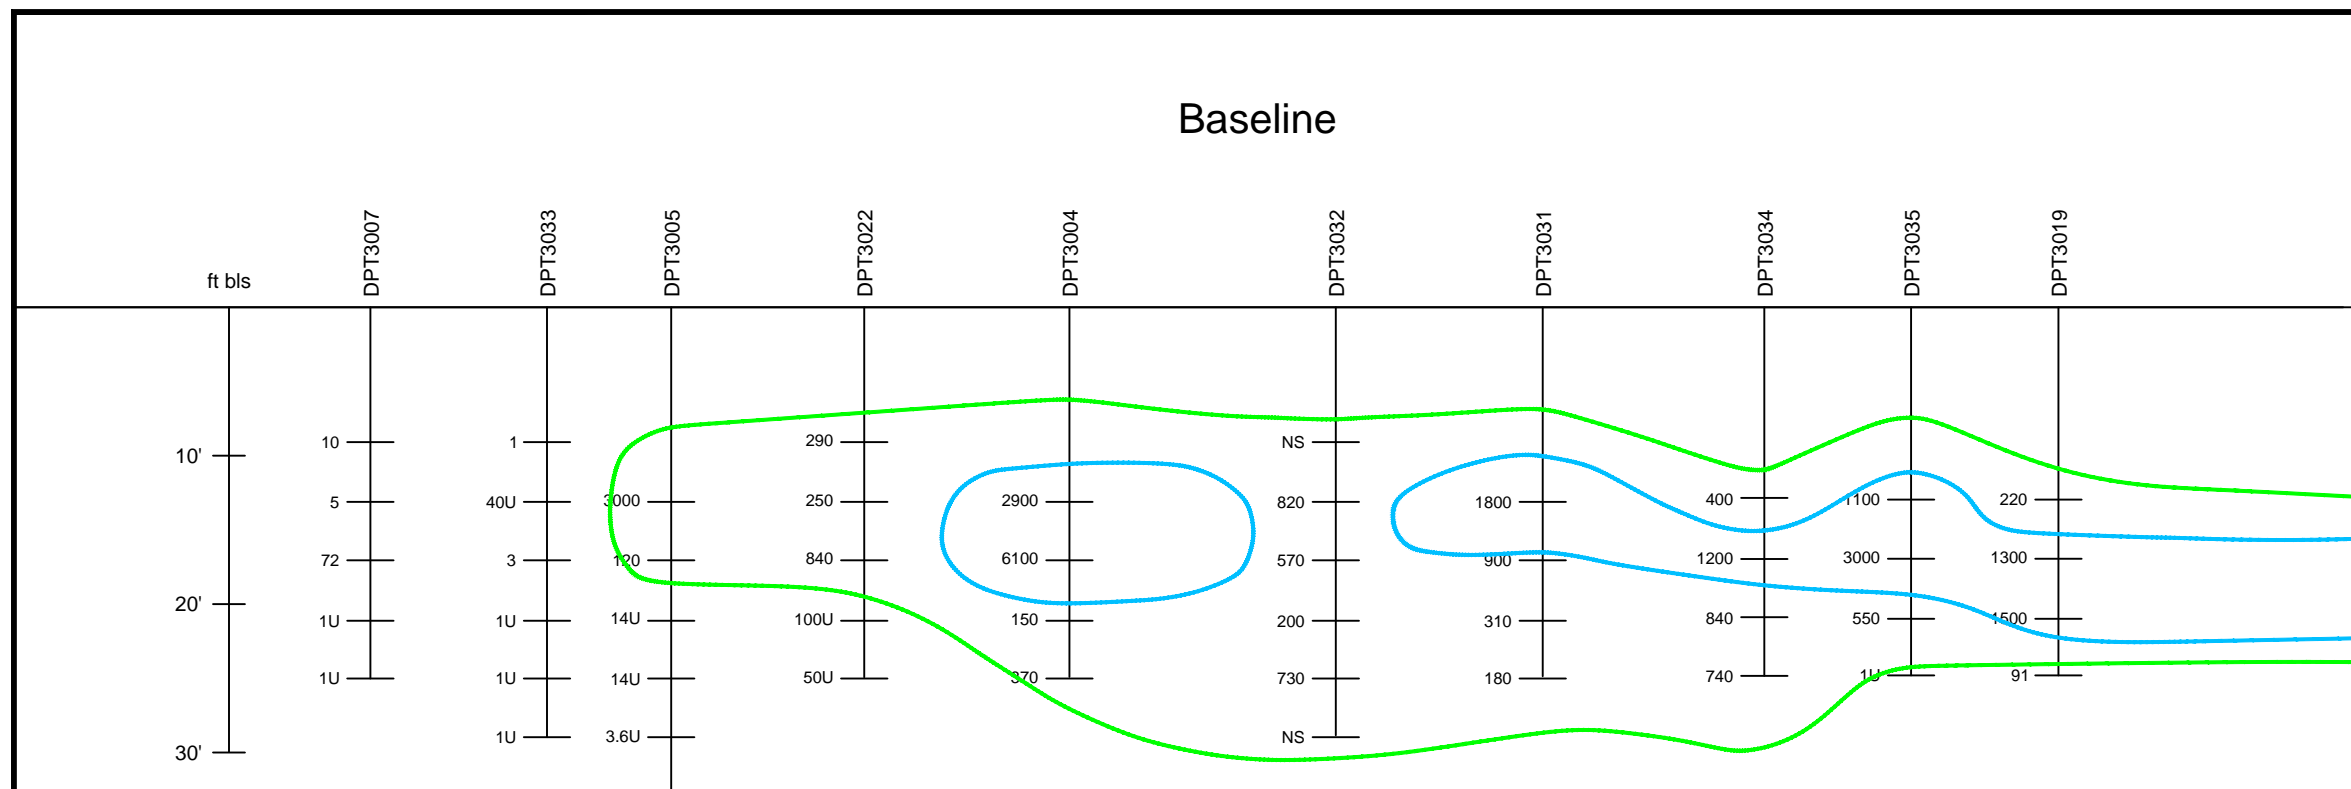
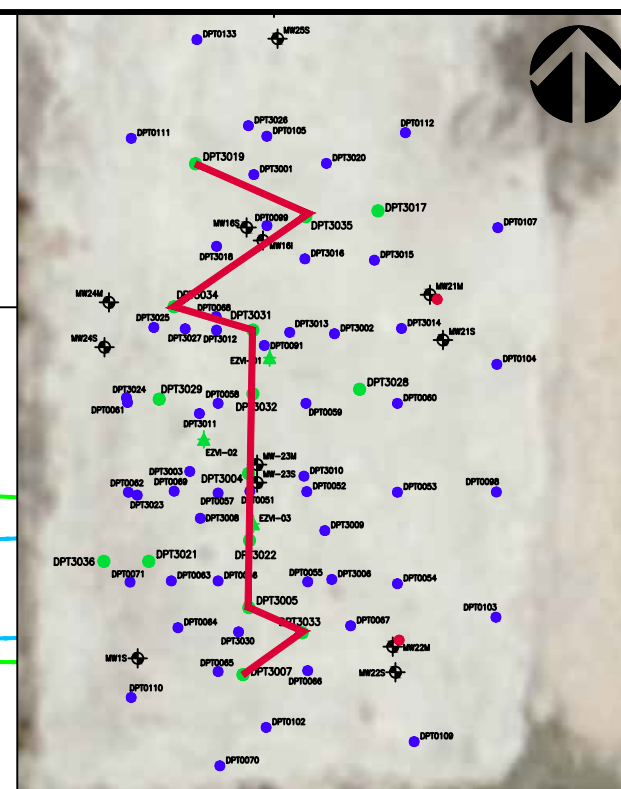
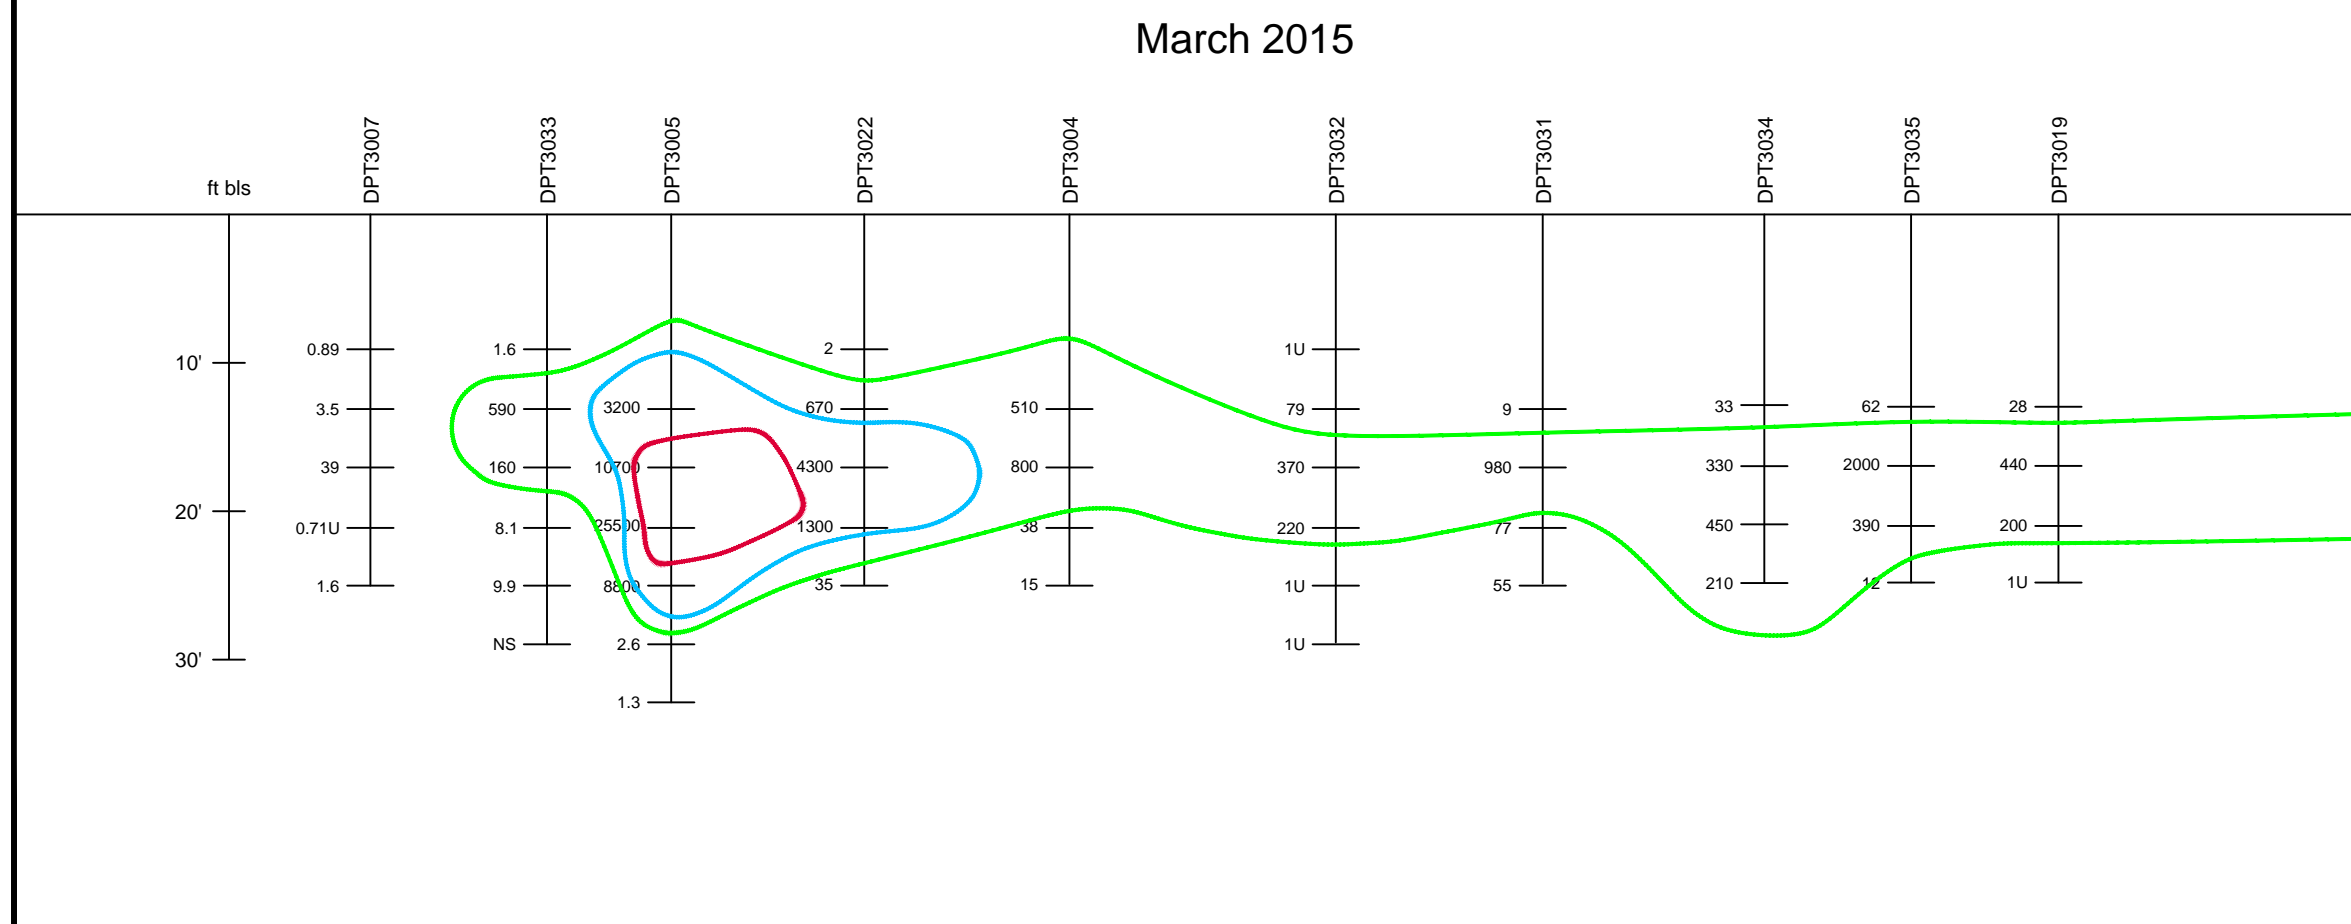
Figure 5-3

-  100 µg/L Vinyl Chloride  
 1,000 µg/L Vinyl Chloride  
 10,000 µg/L Vinyl Chloride

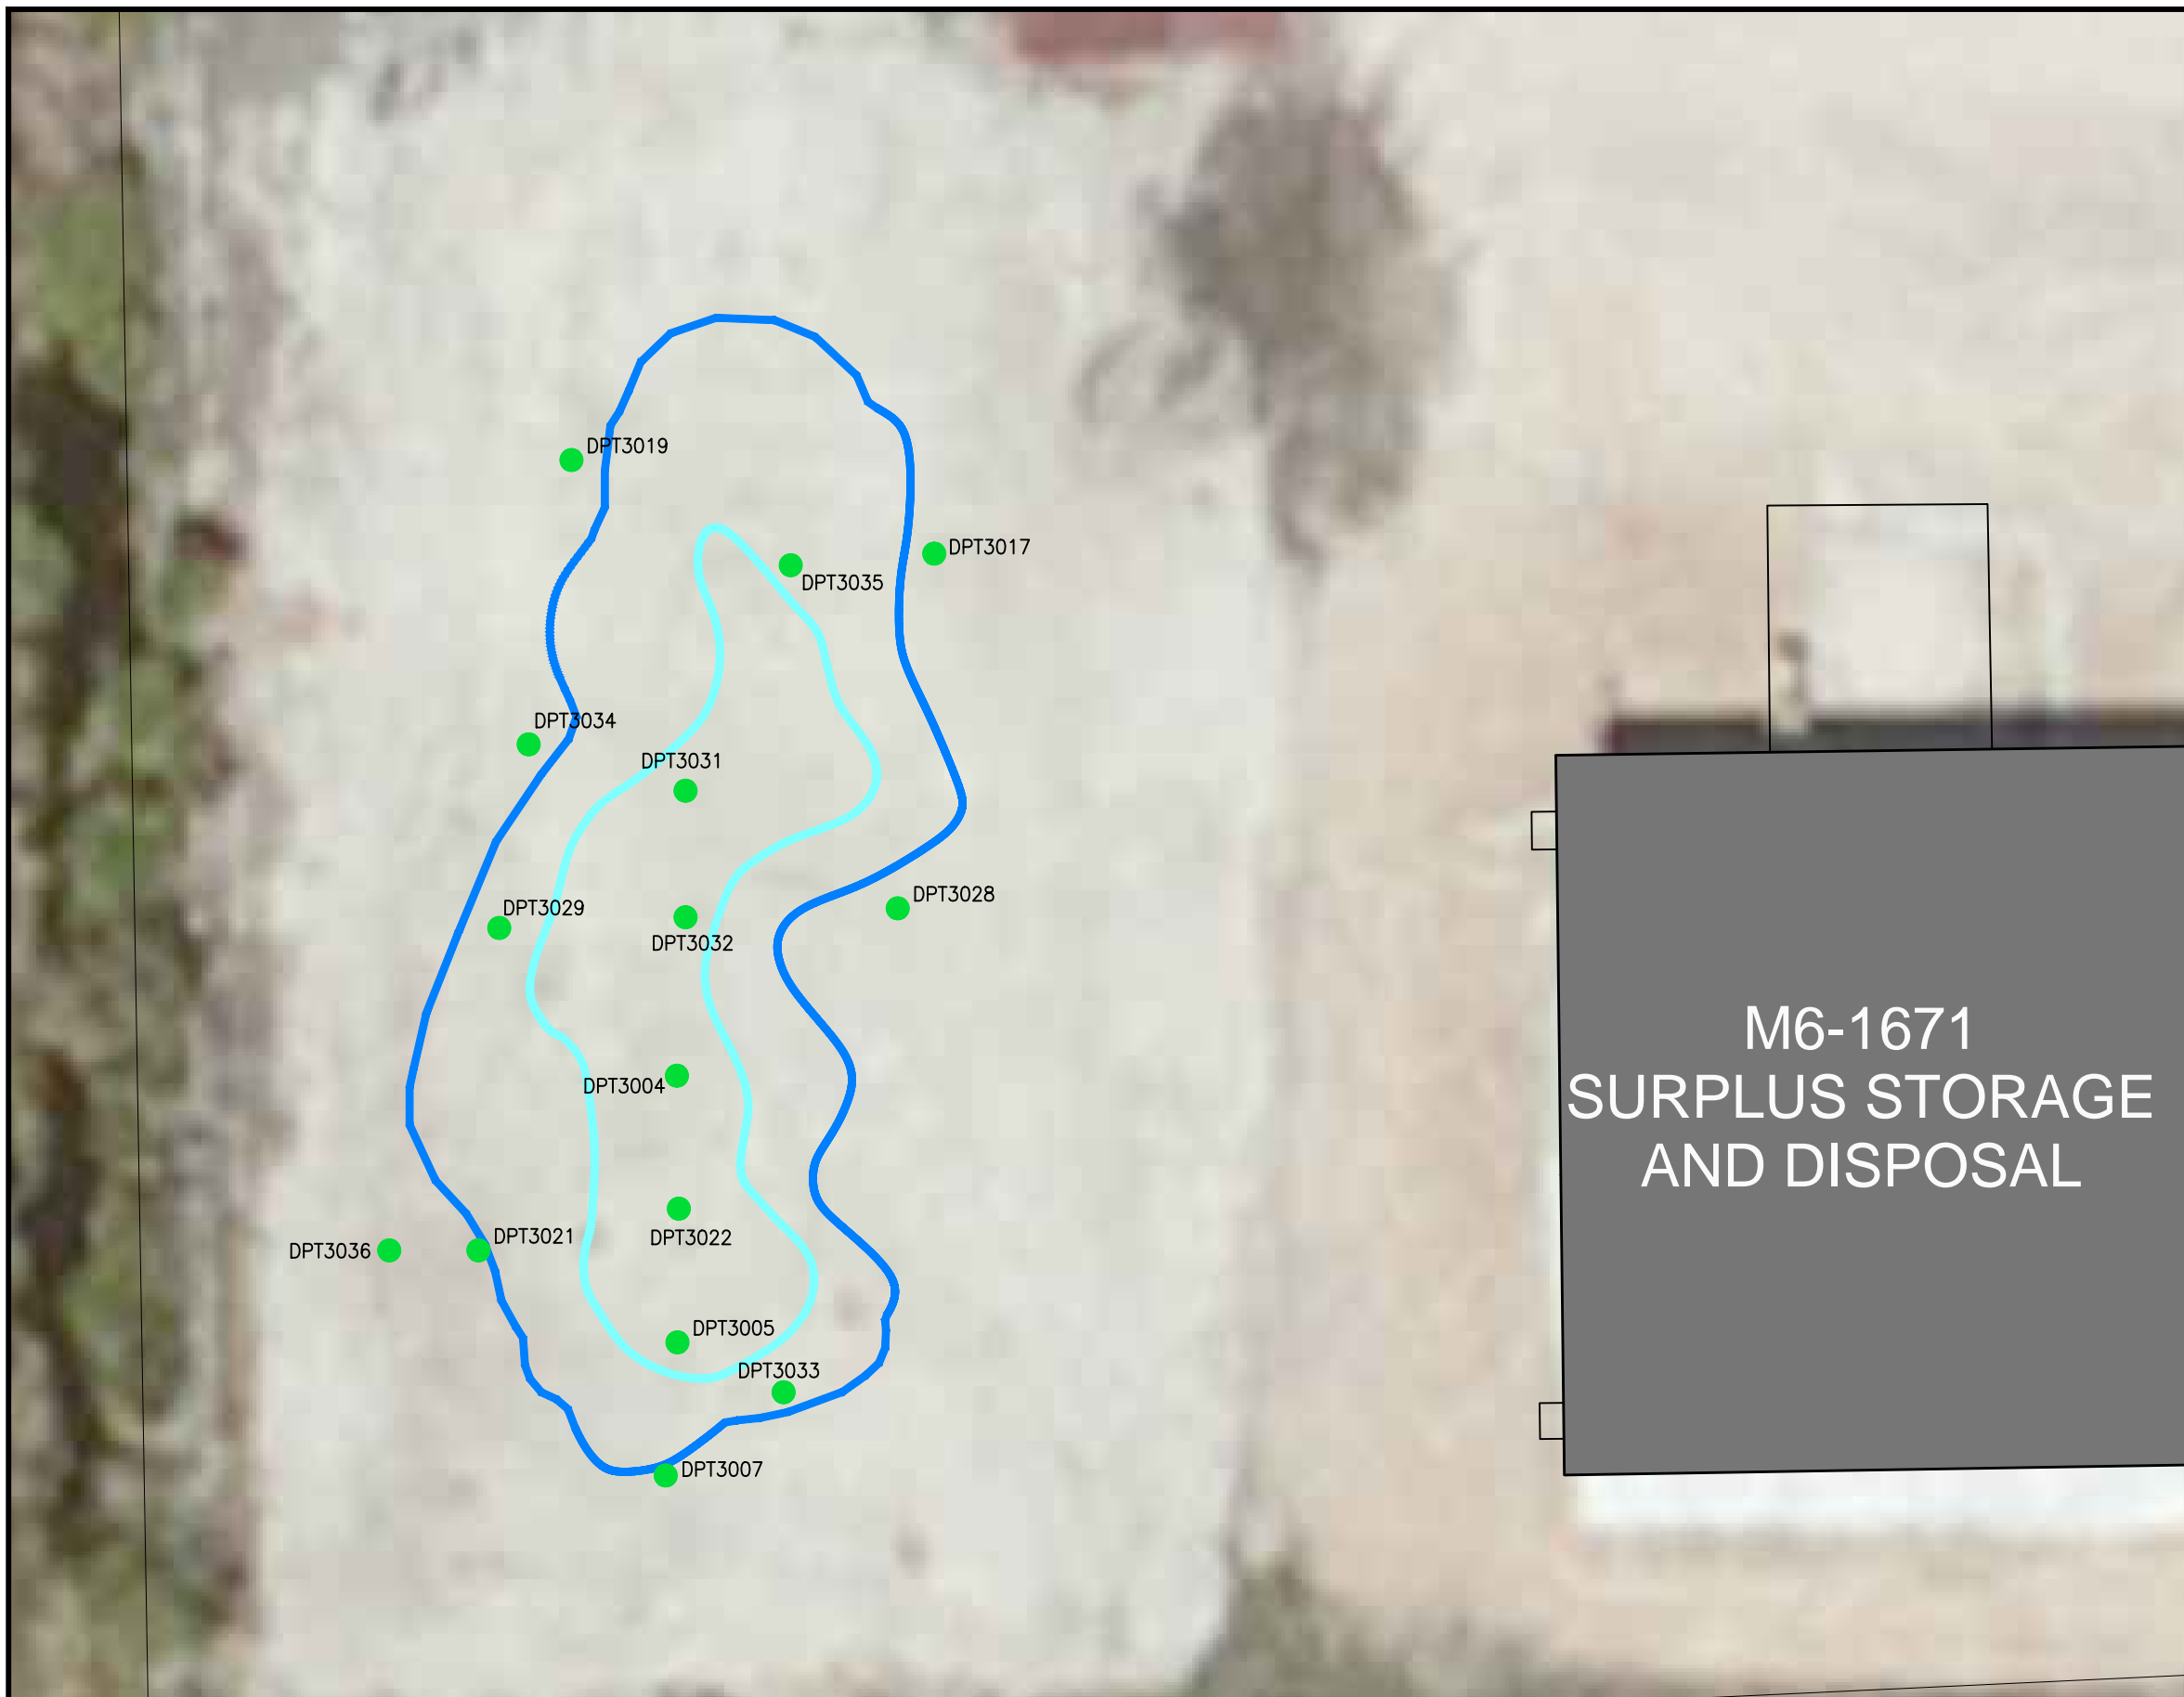
Figure 5-4

DPT3036 is a new groundwater sampling location

It is recommended that a third post-injection performance monitoring sampling event be performed to continue to evaluate the effectiveness of the IM. Sample locations should mirror select locations from the previous performance monitoring sampling events to allow continued comparison of baseline (pre-injection) data with the performance (post-injection) data (Figure 5-4). An additional sample location is recommended west of DPT3021 to monitor for potential movement of mass from injection activities. Data should also be used to assess whether there is a potential for dechlorination to stall and if a supplemental treatment is advisable. UIC parameters are also recommended to be completed at select DPT locations during the third performance monitoring sampling event.

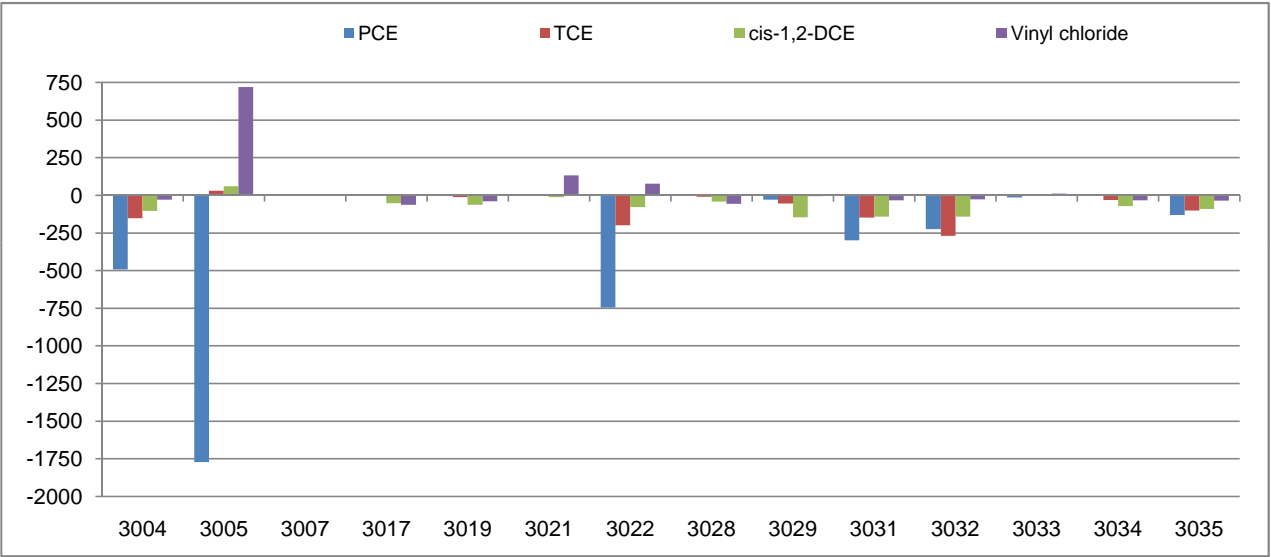
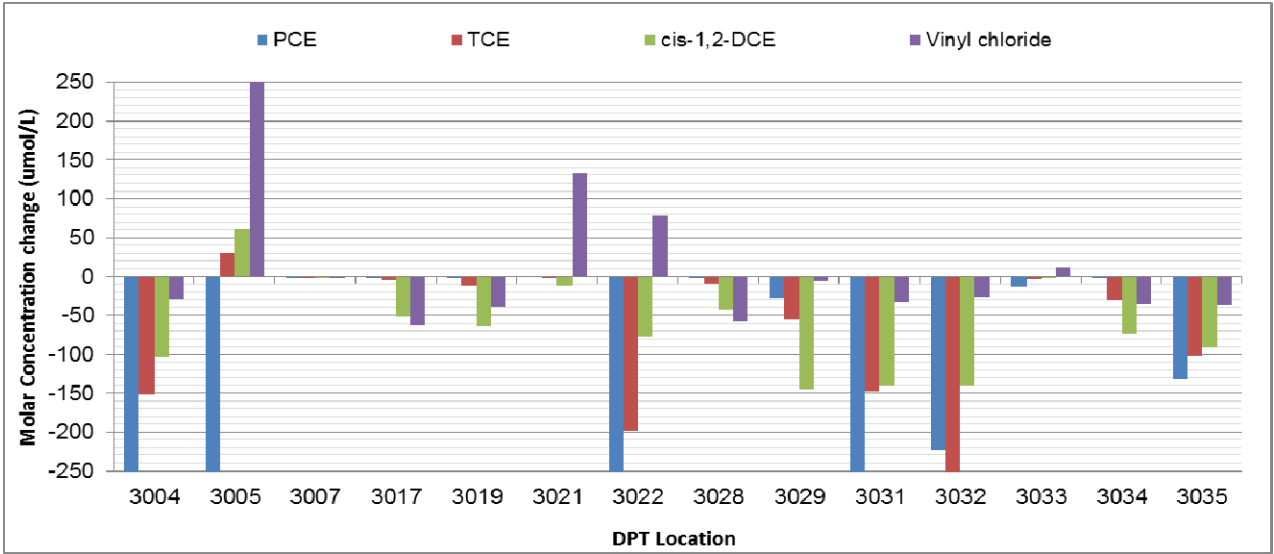
Molar Concentrations for Performance Indicator VOCs  
Southwest Hot Spot  
GSA Reclamation Yard (SWMU 10), Kennedy Space Center
